Materials and Processes Engineering's Role in the Reconstruction and Failure Analysis of The Space Shuttle Columbia

Rick Russell

NASA Orbiter Project Support Office

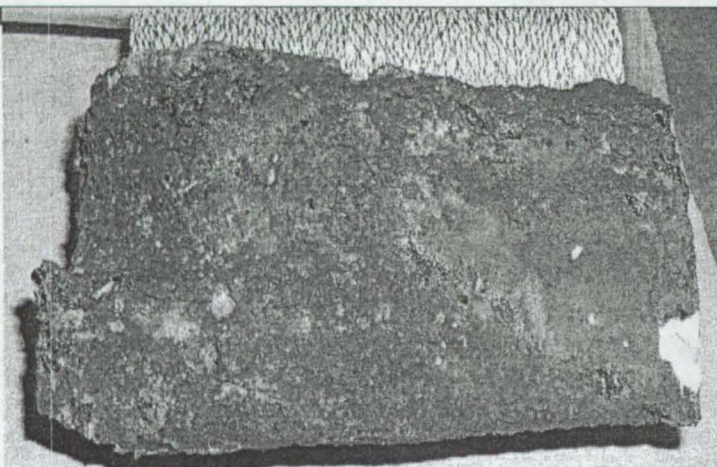
Position 1

Lower Carrier Panel 9 Tiles

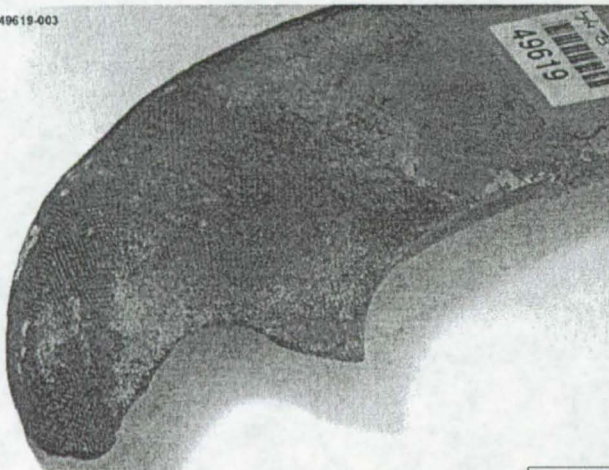
49619-003

Erosion on Panel 8 Upper Inboard Rib

Close-ups of knife edge,
note fibers not visible on
internal surface of panel
due to deposits.

Rib tapers from design
thickness of .365" to .05".

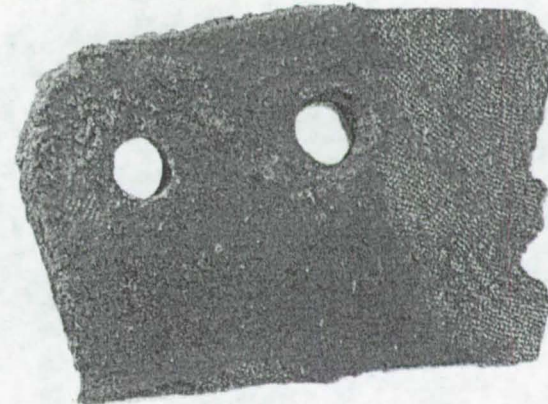
24724-041

Erosion on Gap Surfaces of Panel 8 Outboard Lug & Matching Heel Piece

Lug fragment tapers from design thickness of .499", to a Knife Edge with a minimum thickness of 0.063"

- Matching eroded plies between items 24724 and 58291, shows heat flow external to the panel while panel heel and lug were attached
- Slag deposits at lug attach points - evidence that slag deposited after lug no longer attached to fitting
- Inconel bushings missing at holes

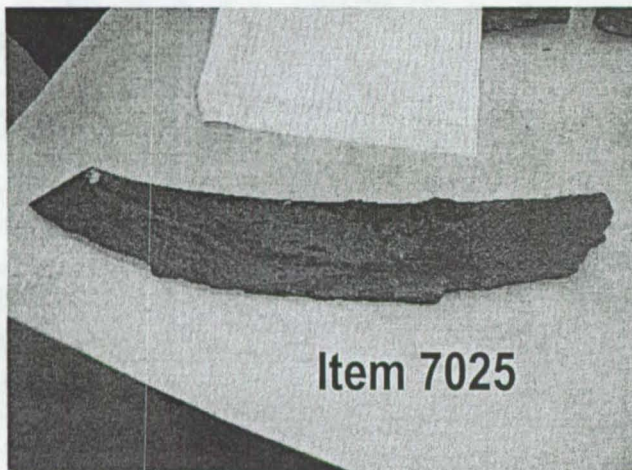
7025 to 52018
interface
shows severe
thermal
erosion –
thickness
ranges from
0.270 to knife
edge of 0.040

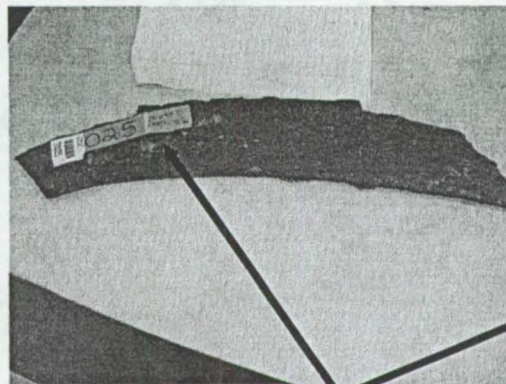
Item 7025

7025 internal side shows
presence of slag deposits

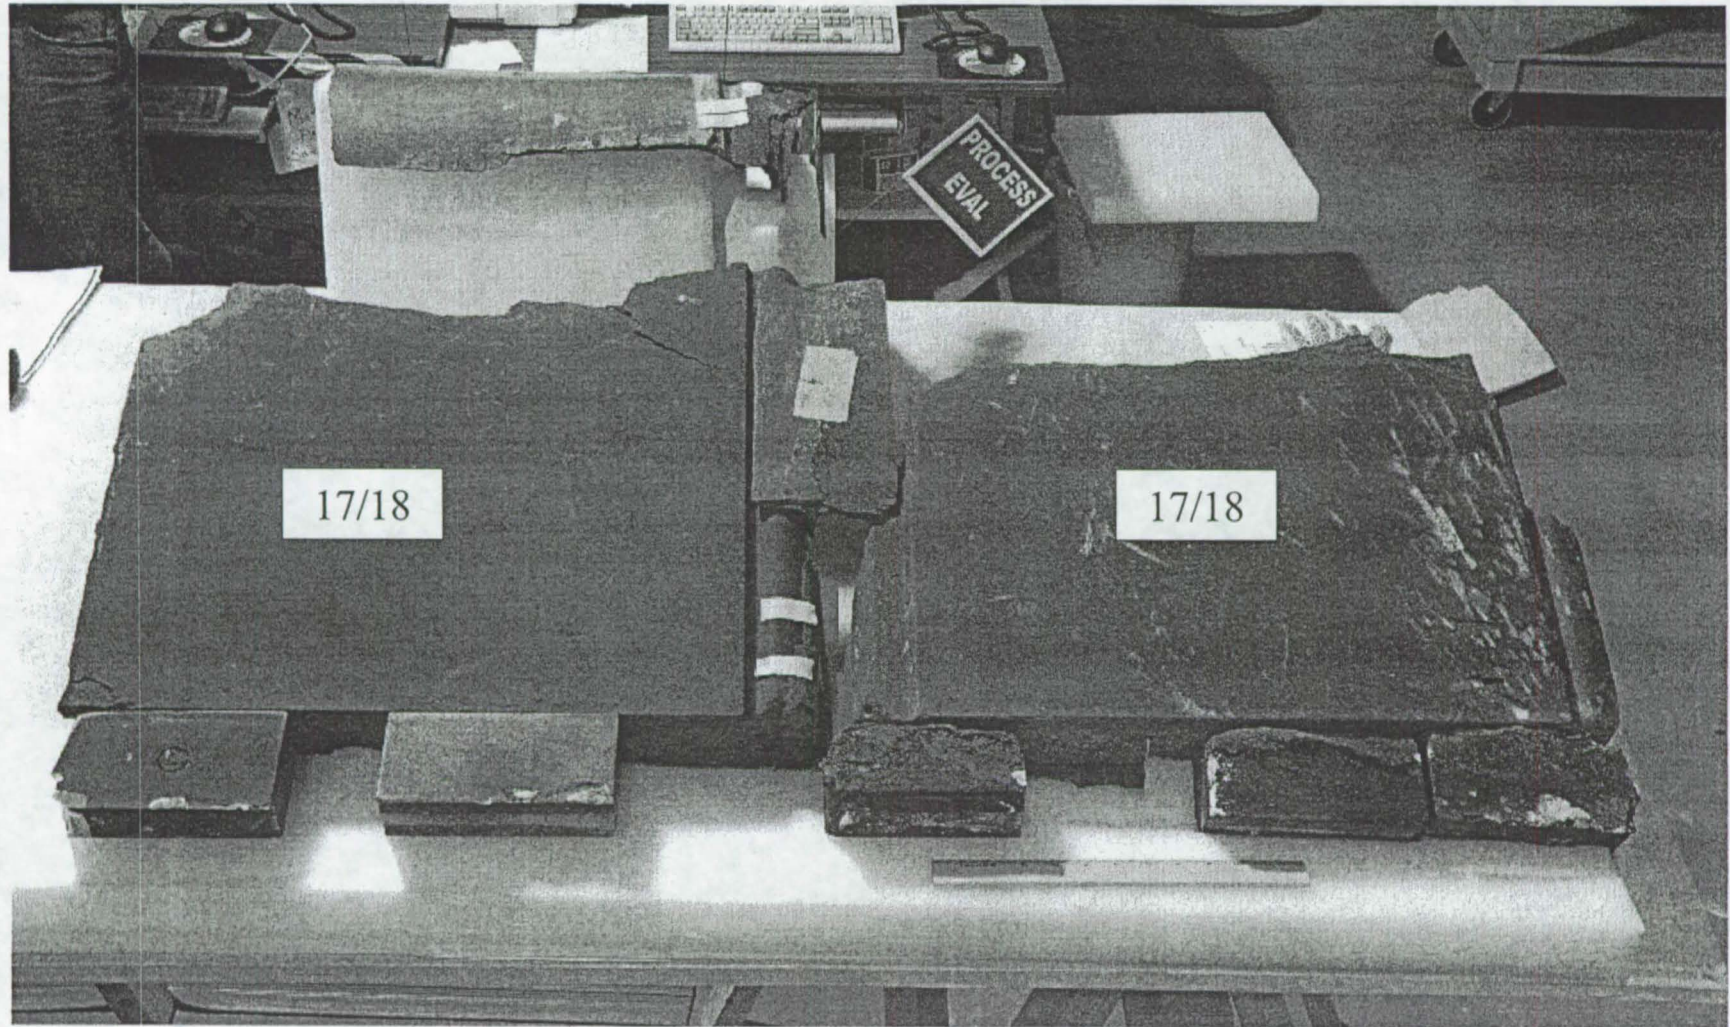
Simulated 8-9 Panel Joint - Lower

- 3-D Simulation required to help visualize plasma flow damage
 - ♦ To better “read” erosion characteristics
 - ♦ Better understand flow patterns
 - ♦ Help deduce what parts must have been present during re-entry
 - To shadow or protect recovered debris
- Panel 8-9 joint simulation was constructed
 - ♦ Used actual debris from 8-9 joint
 - ♦ Used lower RCC panels 17 & 18 to simulate missing lower 8 & 9 panels

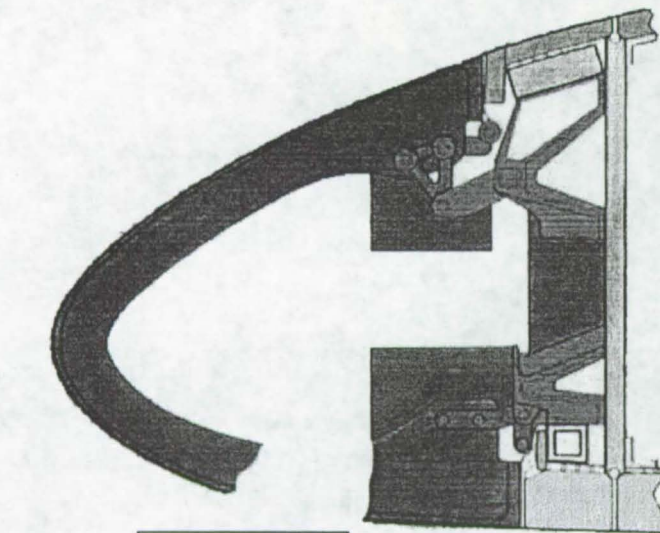
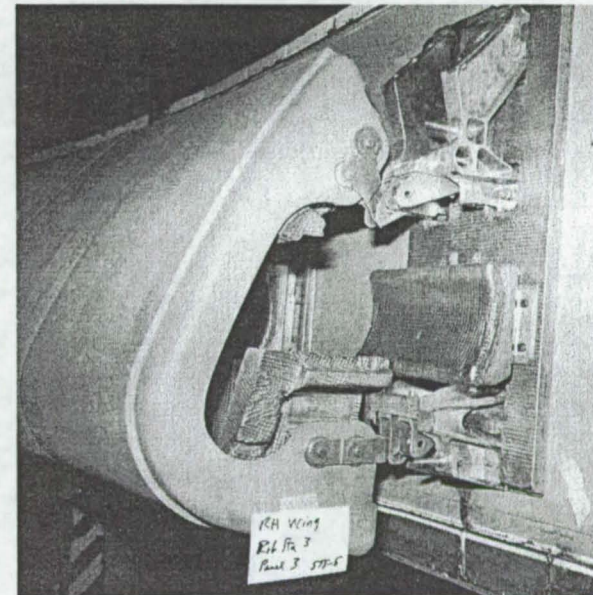
Debris Indicates Highest Probability Initiation Site

- Wing failure initiated in the panel 8 area
 - ♦ Most likely at the panel 8 area near 8-9 joint
 - ♦ Condition existed before or shortly after entry interface

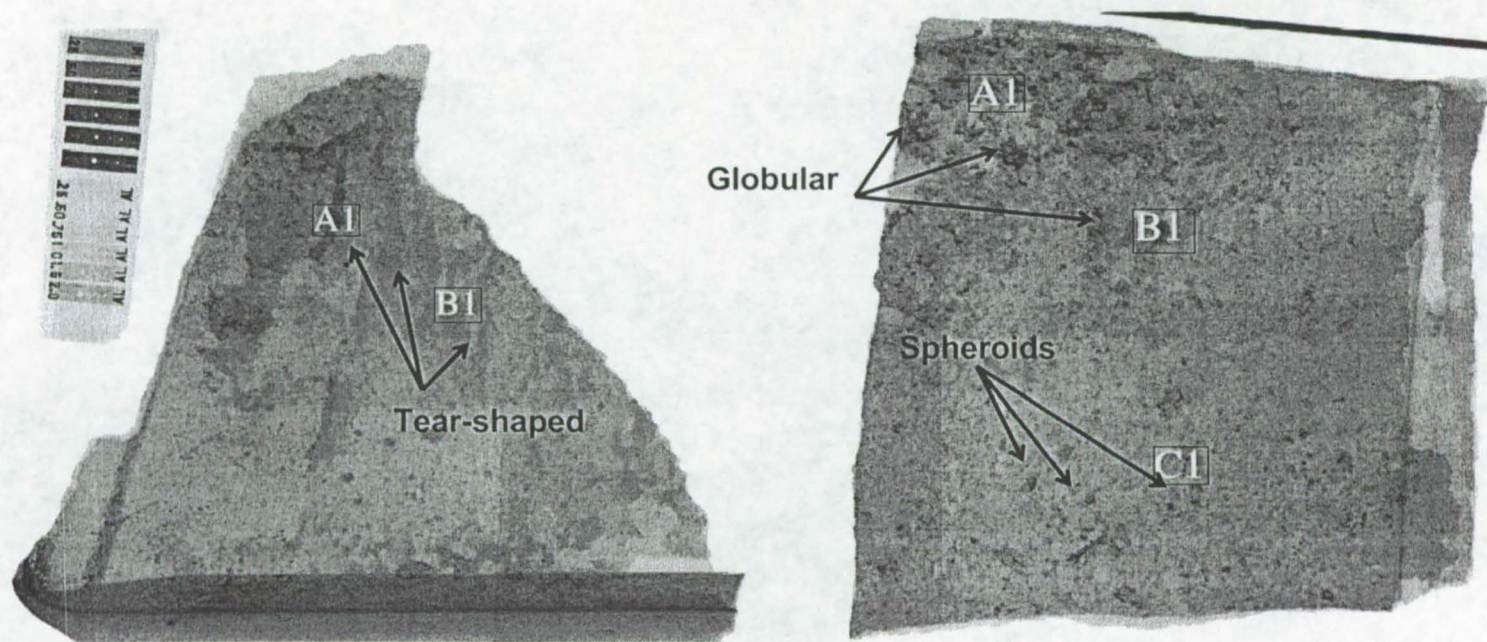
- Four types of deposit patterns were identified from LH RCC Panel 8:
 - ♦ Uniformly thick; Spheroidal; Tear-shaped; Globular

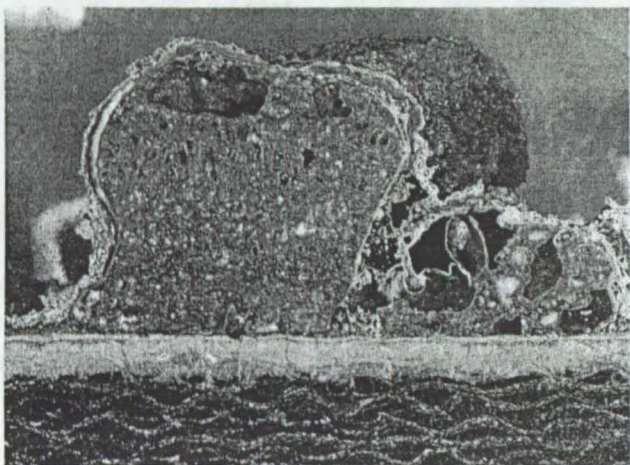
LH RCC 8 – Slag Feature: Thick Tear Shaped

Slag Item 43709, Sample 2A1
